A New Perspective Home Inspections
4404 Blue Wisteria Ct.
Louisville,, KY 40299

Page 4 of 22
23:24 July 27, 2022

Hunter Brooks & Aaliyah Huston
7020 Little Oak Ct

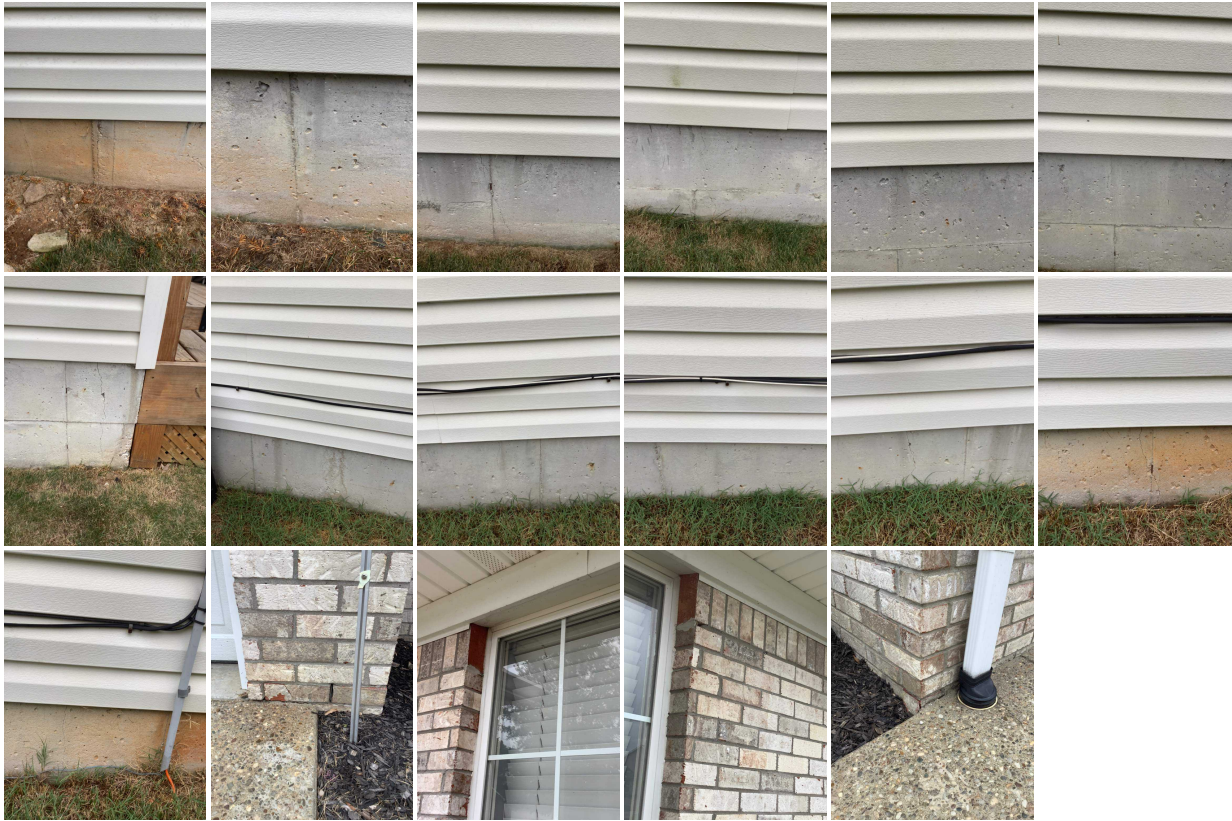
1. Foundation: Poured slab - There are several fine vertical cracks around the exterior raised slab foundation and one diagonal crack on the back right corner. These are typically a sign of normal settling of the foundation. Would recommend monitoring for growth.

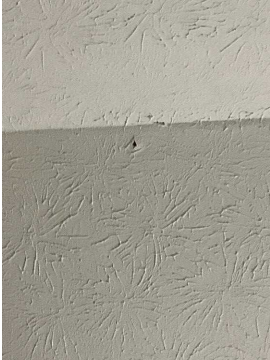
5. Living Room Living Space Ceiling: Texture paint - There is a small hole in the ceiling. Could not access the full attic so could not determine if it goes all the way through

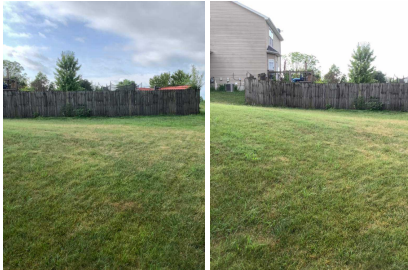
8. Not Inspected Fences: Wood - The property has fencing on each side provided by adjacent properties. The fencing on the right is well-maintained and in good shape. The fencing on the left is in need of repair.

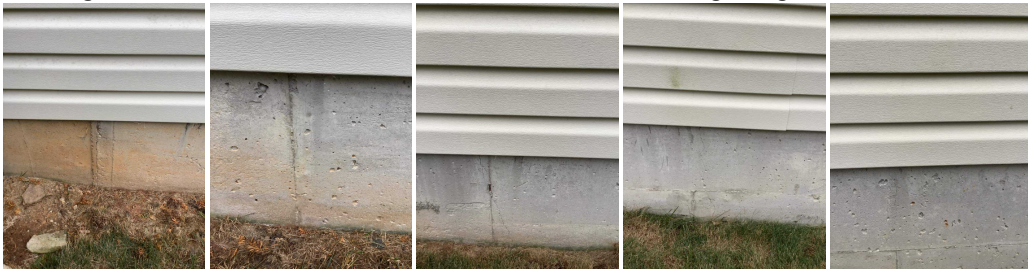
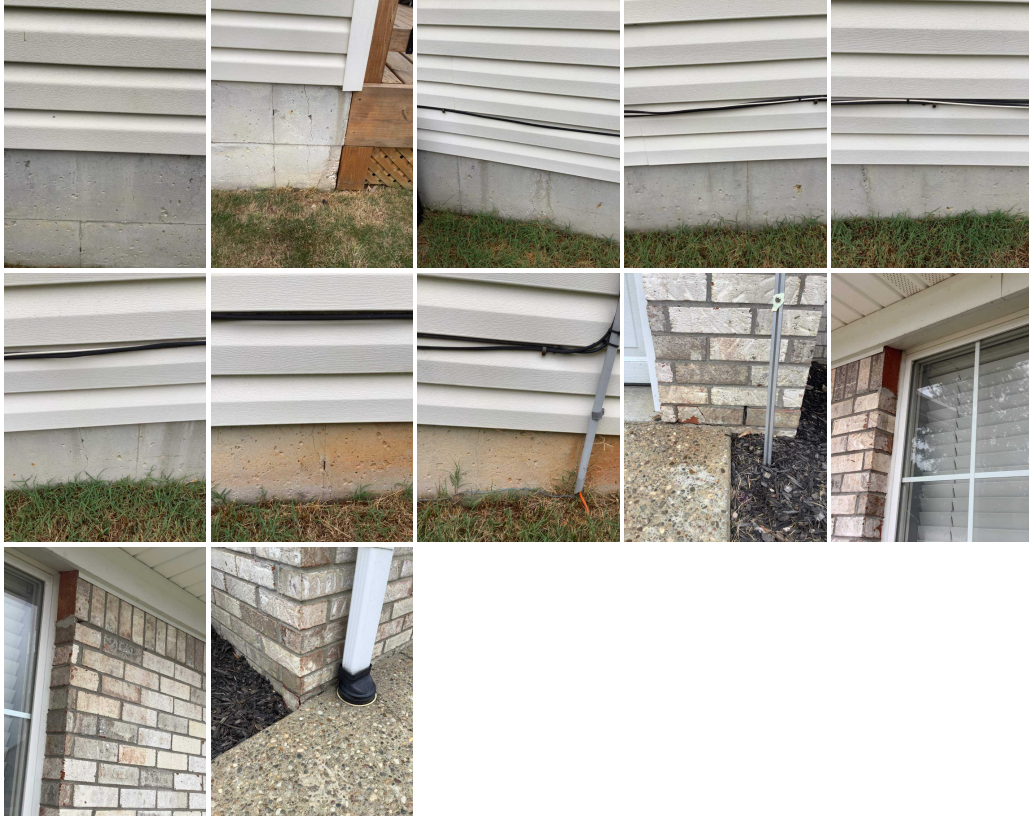
Foundation: (continued)

- 1. Acceptable Structure Type: Wood frame
- 2. Marginal Foundation: Poured slab - There are several fine vertical cracks around the exterior raised slab foundation and one diagonal crack on the back right corner. These are typically a sign of normal settling of the foundation. Would recommend monitoring for growth.

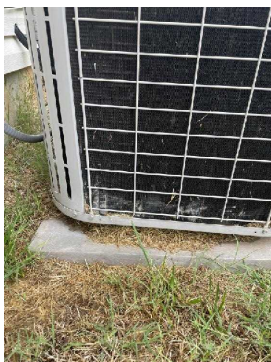
1. Acceptable A/C System Operation: Functional
2. Acceptable Condensate Removal: PVC
3. Acceptable Exterior Unit: Pad mounted
4. Model Number: Data tag removed. Serial Number: Data tag removed
5. Area Served: Whole building Approximate Age: 15 years
6. Type: Central A/C Capacity: Not listed
7. Acceptable Visible Coil: Coils show some slight damage at the bottom. Slight fin damage

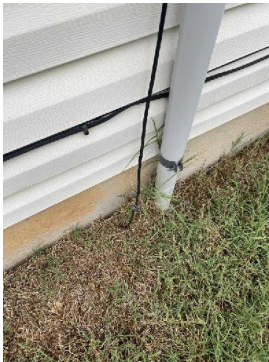
- 5. Acceptable Conductor Type: Romex
- 6. Acceptable Ground: Ground wire is buried and probably connects to the rod. However, ground rod could not be felt.

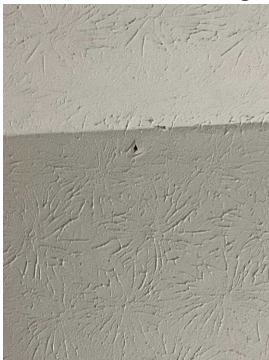
- 2. Marginal Ceiling: Texture paint - There is a small hole in the ceiling. Could not access the full attic so could not determine if it goes all the way through

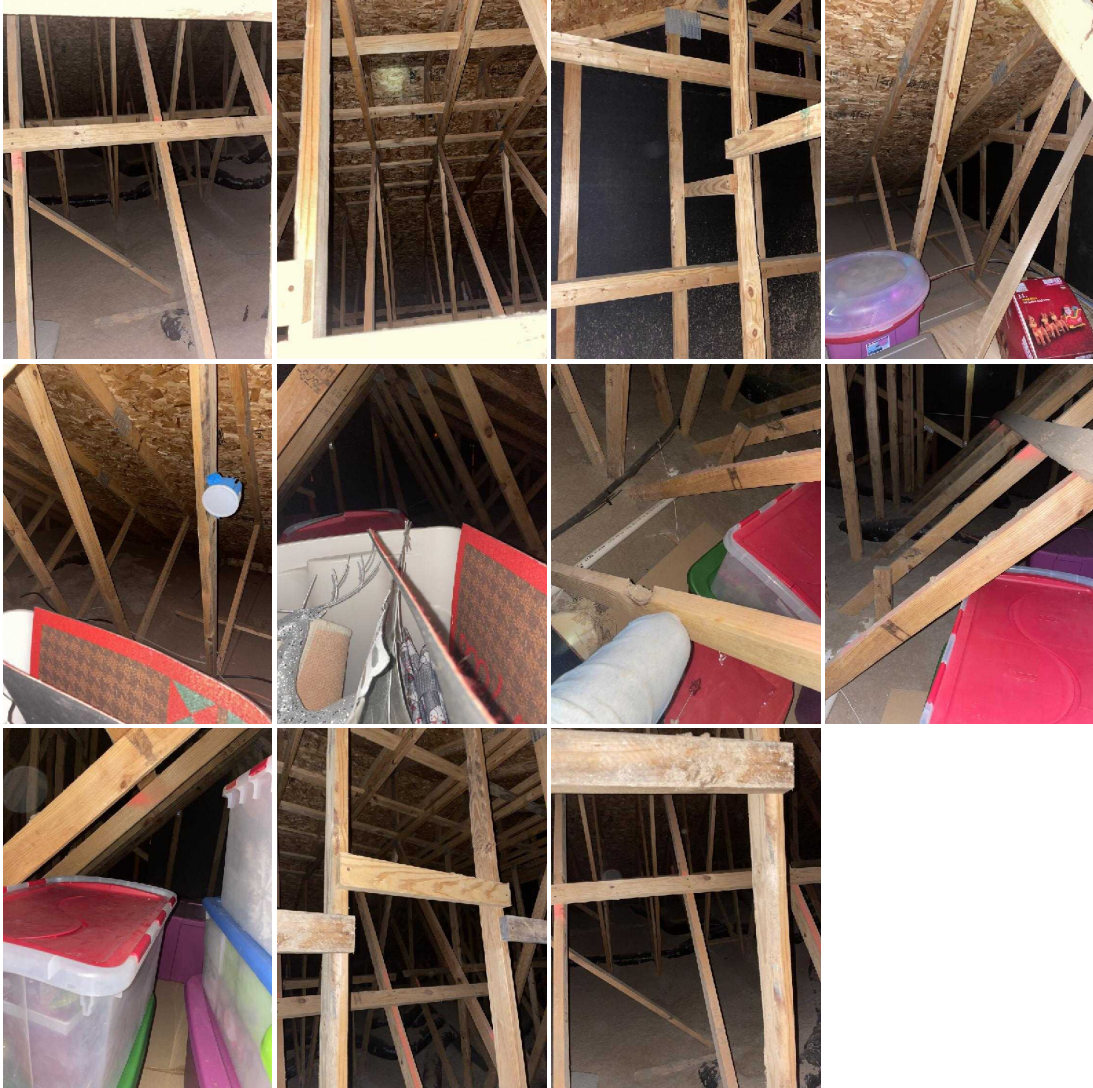
2. Acceptable Unable to Inspect: 70% - Unable to make it completely into the attic. Took pictures from inside the attic at the attic access door only.
